Case Study: Skin Graft

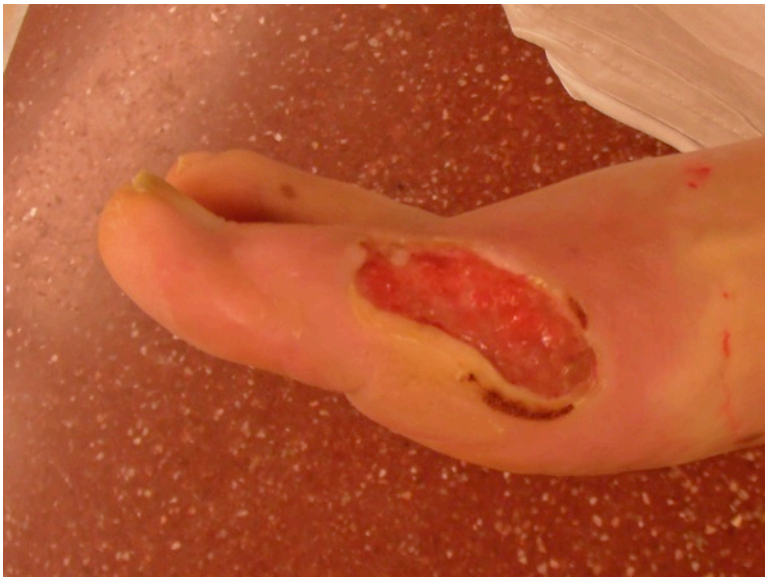
Day 0 – Start of Treatment, Deep Pressure Ulcer

- Female with deep ulcer on right foot
- Patient has already had partial amputation of left foot from similar condition
- Patient received a split thickness skin graft
- CDO applied at 10 ml/hr for 9 days with two-part absorbent foam layer and occlusive dressing to ensure take of graft
- Graft continued to full closure

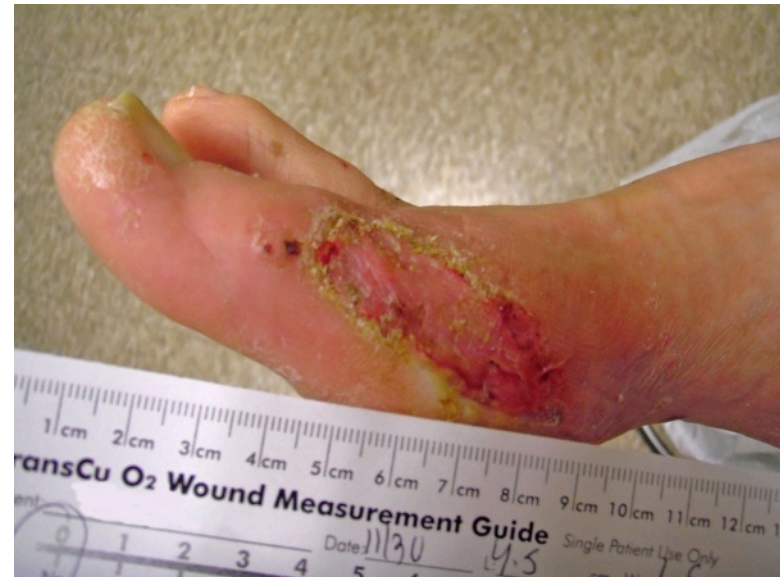
Day 14 – Split Thickness Graft Healing
